**UNITED  
POWER  
SERVICES  
INCORPORATED**

Thermal Inspection at

Your Company

**2** February 2017

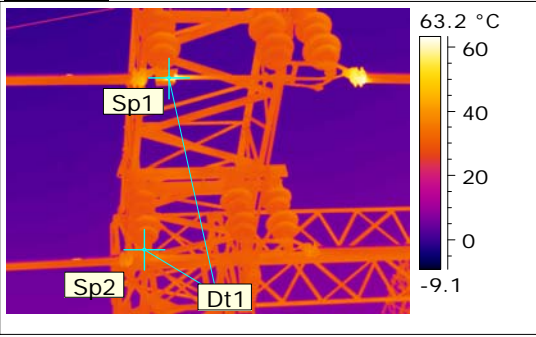
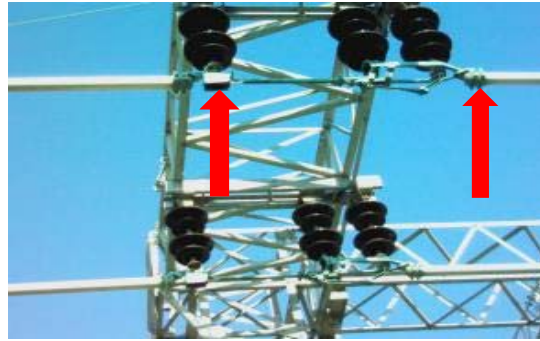
**Photo 1.**

Photo 1 – Main Sub Severity 1. Photo 4 - Bar Line Packaging Severity 1.

Location	Main Substation
Equipment	Switch (SO-22)
Priority Rating	1
Date	8/9/2016
Sp1 Temperature	75.3°C
Sp2 Temperature	40.3 °C
Dt1	35.0 °C

<b>Description:</b> Line 2. Left side of switch right terminal connections.  <b>Note:</b> Appears to be the same problem as scan performed in 2016 where fault temp was 14.5° C. The severity rating has increased.	<b>Probable Cause:</b> Loose and/or corroded switch contacts, pivot point and/or terminal connection. Possible unbalanced load.
<b>Recommended Repair:</b>	
Test load. Clean and reset all connections associated with this unit.	
<b>The reason we recommend to clean and reset all connections is because high fault temperatures can mask other issues in surrounding connections.</b>

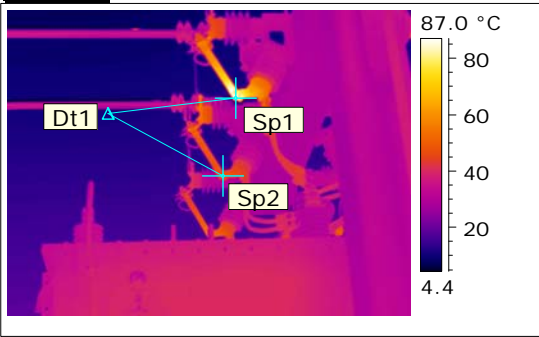
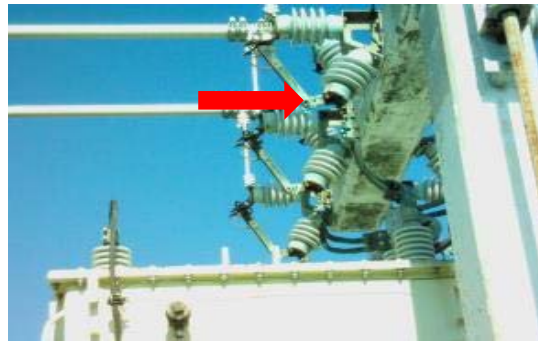
**Photo 2.**

Location	Main Substation Primary Switch For Regulator
Equipment	Switch (SO-21)
Priority Rating	1
Date	8/9/2016
Sp1 Temperature	89.3 °C
Sp2 Temperature	48.6 °C
Dt1	40.7 °C

<b>Description:</b> Right disconnect on road side.	<b>Probable Cause:</b> Possible loose and/or corroded switch contacts, terminal connection, and/or pivot point. Possible unbalanced load.
---	--

**Test load. Clean and reset all connections associated with this unit.**

**The reason we recommend to clean and reset all connections is because high fault temperatures can mask other issues in surrounding connections.**

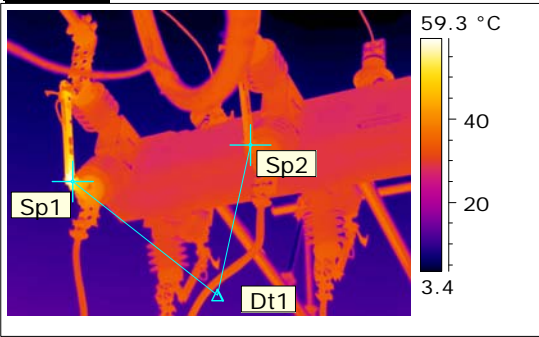
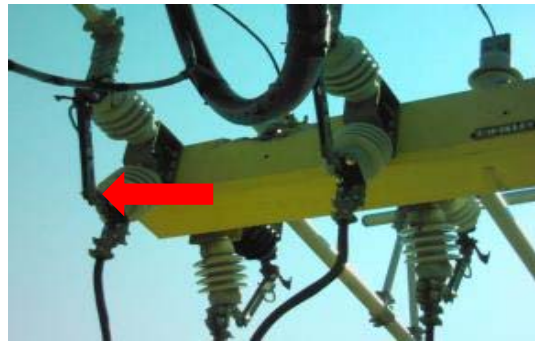
**Photo 3.**

Location	Main Substation Switch For Breaker 9214
Equipment	Breaker 9214
Priority Rating	1
Date	8/9/2016
Sp1 Temperature	61.2 °C
Sp2 Temperature	36.7 °C
Dt1	24.5 °C

<b>Description:</b> Left switch. Back side pivot.	<b>Probable Cause:</b> Loose and/or corroded pivot point and/or terminal connection. Possible unbalanced load.
--	---

**Test load. Clean and reset all connections associated with this unit.**

**The reason we recommend to clean and reset all connections is because high fault temperatures can mask other issues in surrounding connections.**

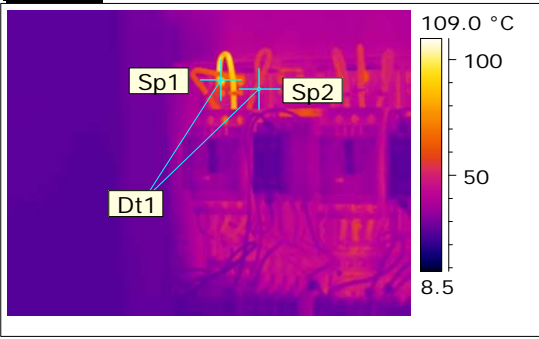
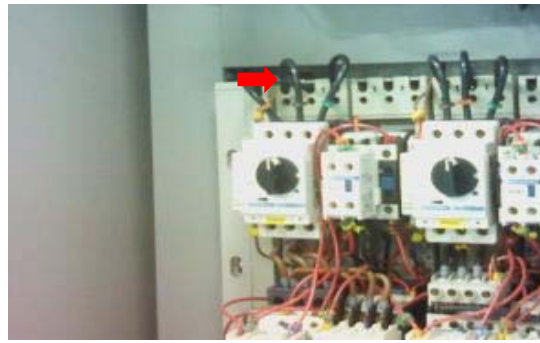
**Photo 4**

Location	Bar Line Packaging
Equipment	Bagging 1 Control
Priority Rating	1
Date	10/17/2016
Sp1 Temperature	97.3 °C
Sp2 Temperature	53.7 °C
Dt1	43.6 °C

AMP READINGS	
Left	14.2
Middle	14.3
Right	14.6

<b>Description:</b> 25-amp circuit breaker F-540102. Top middle phase rear terminal connection.  <b>Note:</b> Appears to be the same problem as scan performed in 2016 where fault temperature was 35.3° C.	<b>Probable Cause:</b> Loose and/or corroded terminal connection. Possible deteriorating breaker. Possible conductor damage.
<b>Recommended Repair:</b>  <b>Test breaker and inspect conductor. Replace breaker and conductor if needed. Clean and tighten all terminal connections associated with this unit.</b>  <b>The reason we recommend to clean and reset all connections is because high fault temperatures can mask other issues in surrounding connections.</b>

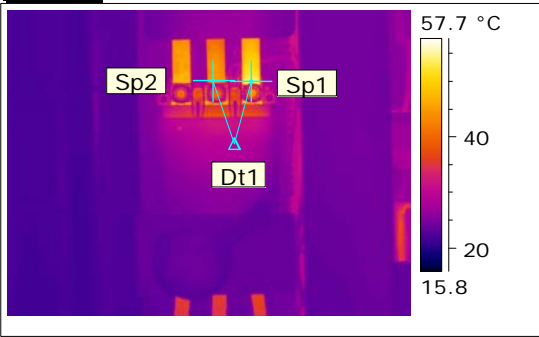
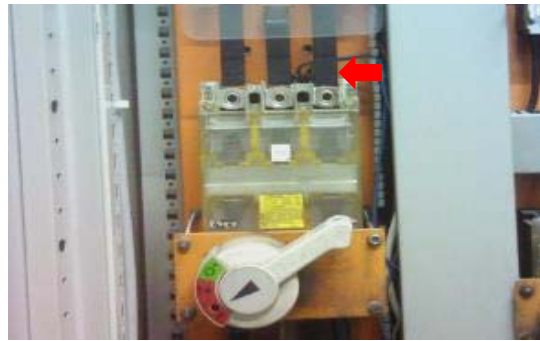
**Photo 5**

Location	Waste Water Treatment MCC
Equipment	Main Disconnect For Bay
Priority Rating	2
Date	10/18/2016
Sp1 Temperature	54.1 °C
Sp2 Temperature	45.3 °C
Dt1	8.8 °C

AMP READINGS	
Left	142.8
Middle	143.0
Right	140.6

<b>Description:</b> 250-amp main disconnect F0. Top right bus bar connection.	<b>Probable Cause:</b> Loose and/or corroded bus bar connection.
--	---

**Clean and reset all terminal connections associated with this unit.**

**The reason we recommend to clean and reset all connections is because high fault temperatures can mask other issues in surrounding connections.**

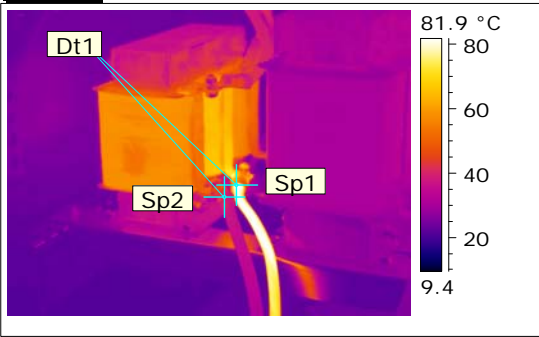
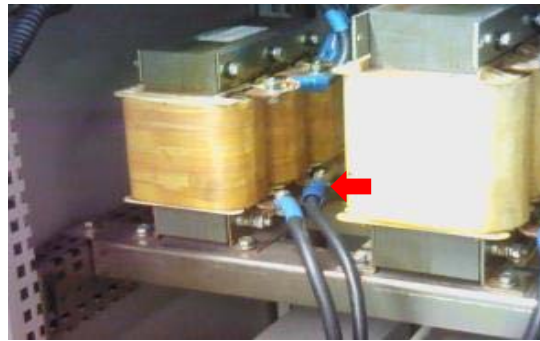
**Photo 6**

Location	Waste Water Treatment MCC
Equipment	Bay 6 Transformer
Priority Rating	1
Date	10/18/2016
Sp1 Temperature	85.5 °C
Sp2 Temperature	40.5 °C
Dt1	45.0 °C

AMP READINGS	
Left	76.6
Middle	76.8
Right	77.4

<b>Description:</b> Transformer. Bottom middle phase crimp terminal connection.	<b>Probable Cause:</b> Loose and/or corroded terminal connection and possibly the crimp connection.
--	--

**Clean, tighten and recrimp all terminal connections associated with this unit.**

**The reason we recommend to clean and reset all connections is because high fault temperatures can mask other issues in surrounding connections.**

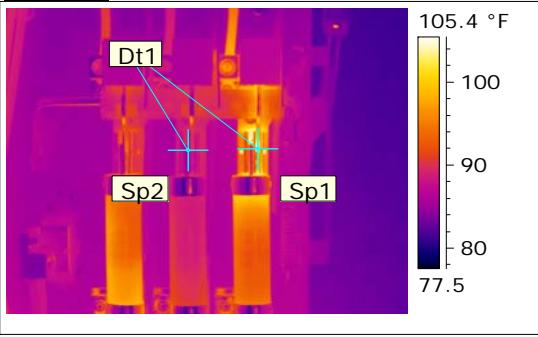
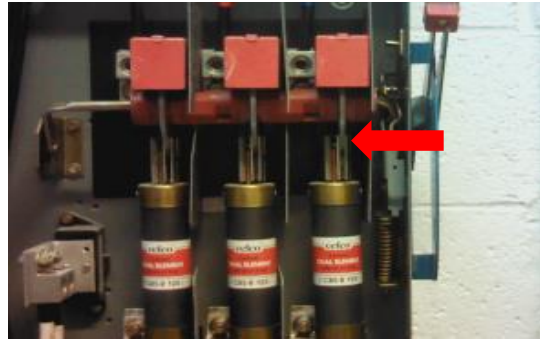
**Photo 7**

Location	Boiler Room
Equipment	Boiler 1 Fused Disconnect)
Priority Rating	3
Date	12/12/2016
Sp1 Temperature	45.0 °C
Sp2 Temperature	42.9 °C
Dt1	2.1 °C

AMP READINGS	
Left	53.3
Middle	24.0
Right	34.6

<b>Description:</b> 125-amp right phase fuse. Top fuse clip, switch contacts, pivot point and/or terminal connection.	<b>Probable Cause:</b> Unbalanced load. Loose and/or corroded fuse clip, switch contacts, pivot point and/or terminal connection.
--	--

Balance load if possible. Clean and reset all connections associated with this unit.

**The reason we recommend to clean and reset all connections is because high fault temperatures can mask other issues in surrounding connections.**
